Re: January 2017 Monthly Progress Report
Administrative Settlement Agreement and Order on Consent for Removal Action
U.S. EPA Region 10 Docket No. CERCLA 10-2009-0255
Gasco Sediments Site within the Portland Harbor Superfund Site

Attachment A Monthly Visual Monitoring Report for Pilot Cap Vicinity

Project: NW Natural – Gasco

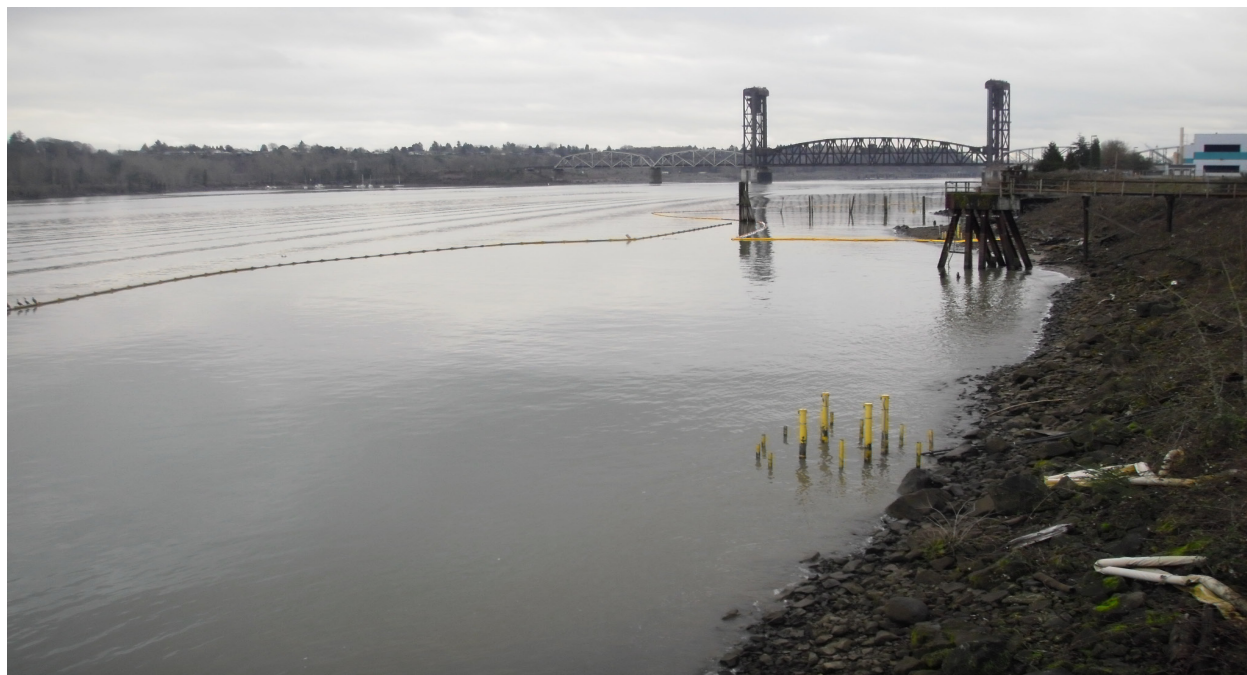
Photo 1

No erosion/deposition is evident along the shoreline. The shoreward extent of the cap was not visible due to high river water elevation and the organoclay mat material shoreward of the cap area could not be observed (Photo 1).

River Level Currently Above the Extent of Sediment Cap (1/26/2017)

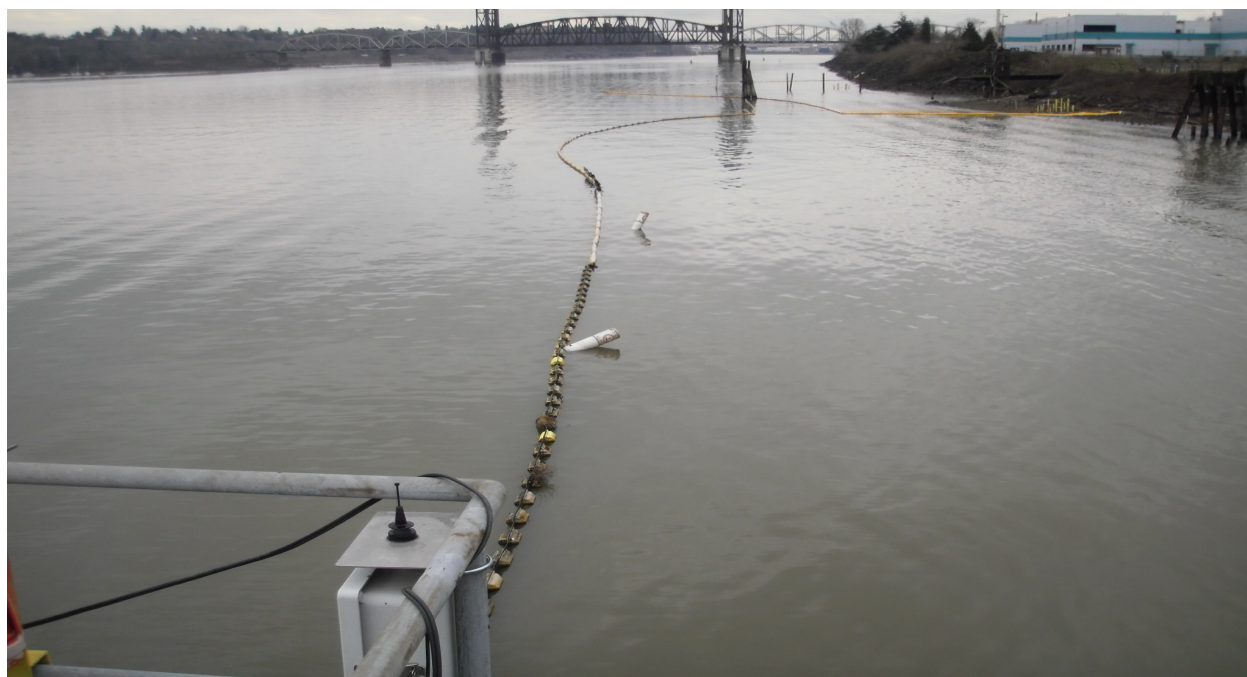
Photo 2

During the observation, the FAMM containment boom was placed across the cap area from the ship dock to the upriver dolphin. Two buoys that identify the cap area to mariners are in place as installed. The positions of the FAMM oil boom and warning buoys are shown in Photo 2.

FAMM Oil Boom Placement and Mariner Warning Buoys at Pilot Cap Area (1/26/2017)

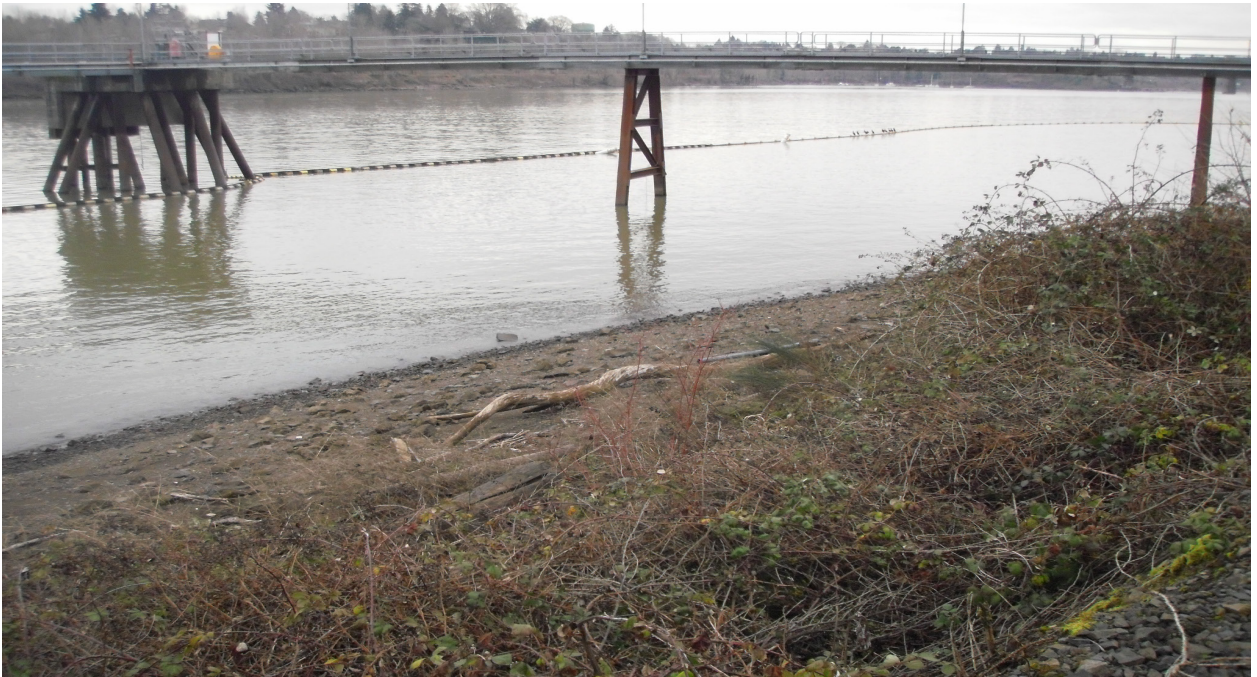
No sheen is evident in or around the cap area. Photo 3 shows the water surface and shoreline immediately downriver of the sediment cap.

Photo 3
Conditions Immediately Downriver of Cap Area (1/26/2017)
